# Safeguarding industries...

## Pioneering inspection technologies for industrial sprinkler systems

by Paul Jackson, Director of LRUT and MFL Centre of Excellence, and Andrew Simpson, Technical Sales and Applications Engineer, Eddyfi Technologies

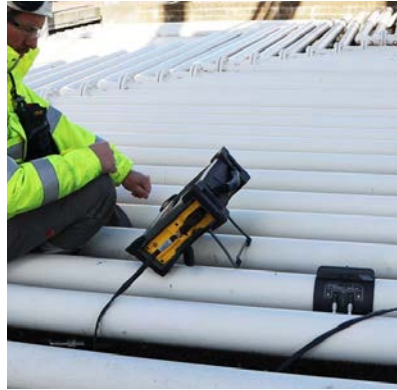
*Figure 1: The Sonyks Magneto-Tool for 4-inch diameter pipes at a 128kHz test frequency. This tool, characterised by its lightweight and low-profile design, can be swiftly installed using a standard torque wrench, simplifying the inspection process dramatically.*

Central to this innovation are the magnetostrictive collars, unassuming in appearance but formidable in function. These collars incorporate a magnetic strip and an electromagnetic acoustic transducer (EMAT) coil, housed securely within a simple clamp. What makes them remarkable is their ability to induce ultrasound into pipes through a torque-driven mechanical coupling, all without fuss or complexity.

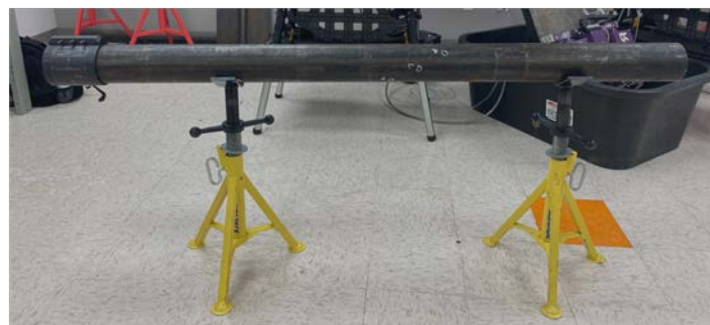
*Figure 2: Diagram and schematic of the 4.5-inch (114mm) test pipe.*

A calibration pipe provided by an Eddyfi Technologies client for NDT inspection equipment pretesting featured the following specifications: *Diameter: 4.5 inches (114 millimeters)* *Wall thickness: Schedule 80, measuring 0.337 inches (8.56 millimeters)* *Length: 6 feet (1.83 meters)*

Eight 1/16-inch (1.5 millimeters) diameter drilled holes, positioned at 45° angles with 3-inch (76 millimeters) spacing along the pipe.

A section of the pipe exhibited gradual thickness reduction, with a maximum thinning of 1/16 inch (1.5 millimeters) occurring over a 3-inch (76 millimeters) length.

For a visual representation of the calibration pipe, please refer to Figure 2, which includes both a schematic and a photograph for reference.

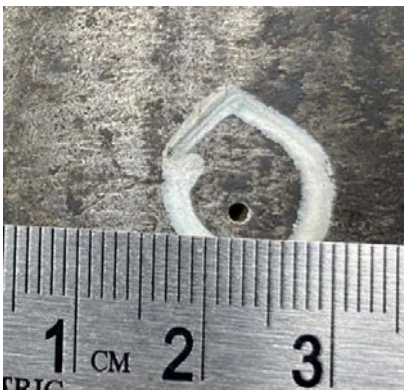
Figure 3: Close-up photographs of the drilled holes and the thinned areas requiring detection.

A close-up of the defects that were included in the pipe shows the diameter of the holes and the thinned area in Figure 3.

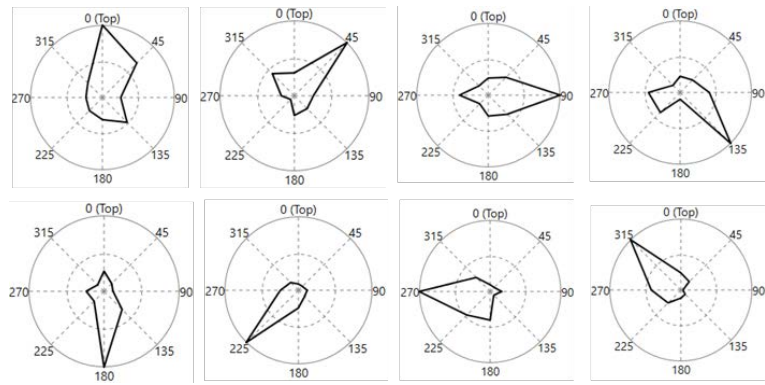
Figure 5: This figure displays the results of focusing efforts, showcasing the rotation of the defects along the entire circumference, ranging from 0° to 315°.

To gain further insights and enhance defect resolution, secondary focusing techniques were employed. By adjusting the focal length and focal distance of the data, each defect could be individually inspected and the rotation of all eight defects around the pipe, covering angles from 0° to 315°, was mapped. These focus plots are visualised in Figure 5.

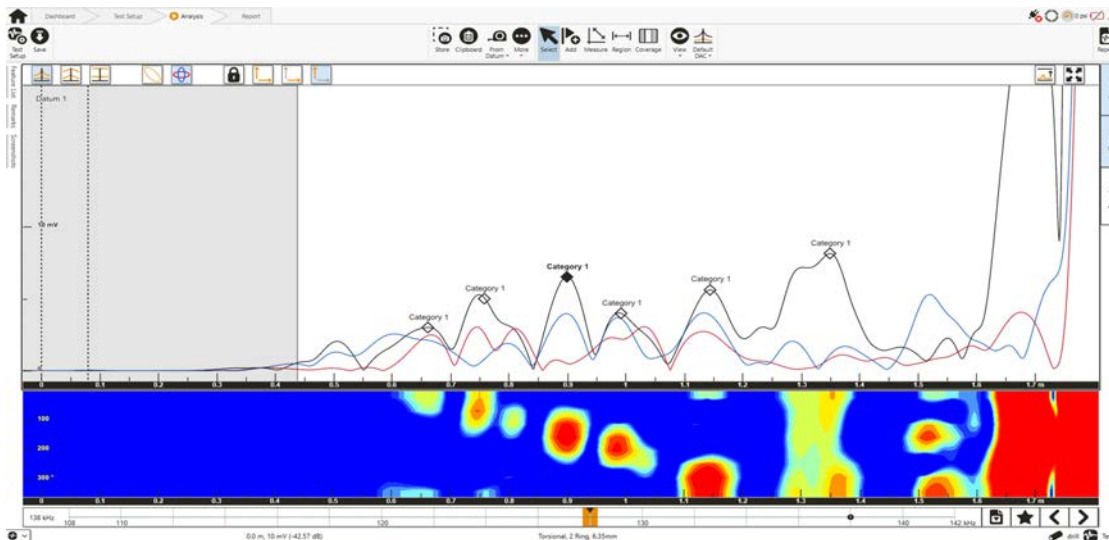
Figure 4: This figure presents an A-Scan and a colour map of the data, highlighting the defects within the pipe. The coloured spots on the map directly correspond to the defects, and their rotation closely matches the rotation of the actual defects on the pipe.

Upon interpretation, an exceptionally favorable signal-to-noise ratio was observed in this sample. Consequently, all defects within the sample were successfully detected. The resulting C-Scan image revealed six distinct coloured spots, corresponding to the locations of the eight defects present. Although the pulse length of the data collection fell just short of individually resolving all eight defects, a clear pattern emerged. These six spots consistently rotated around the pipe in alignment with the positions of the defects in the pipe. Furthermore, pipe thinning was detected between 5 feet and 5 feet, 3 inches (1.29-1.37 meters) from the pipe end. This thinning formed a circumferential band in the C-Scan. The data can be observed in Figure 4.

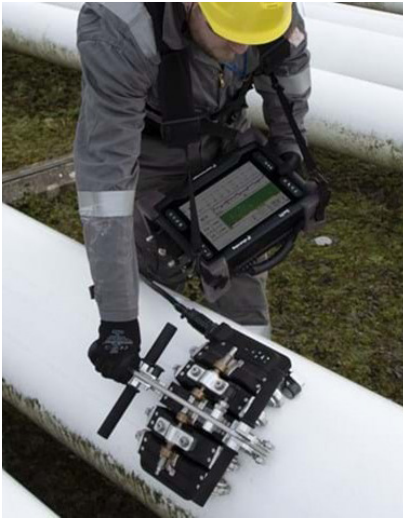
Figure 6: Pipescan HD deployment inspecting pipe for corrosion.

Deploying the Pipescan HD (as illustrated in Figure 6) is remarkably simple, thanks to its unique single curvature adjustment tool. This tool ensures swift inspection setup without the need for couplant or intricate gate settings. The process entails connecting the Pipescan HD to the data acquisition instrument, entering inspection details, and the system is ready for operation.

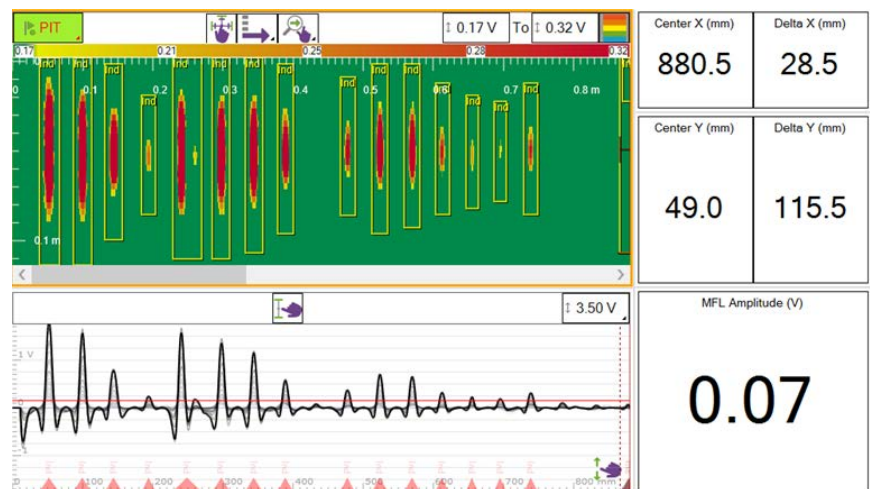
Figure 8: Software clearly displaying different corrosion defects within the pipe sample.

Inspecting the half pipe was a straightforward one-pass process, taking approximately 15 minutes from setup to scan to report generation. Most defects were conspicuously visible, as demonstrated in Figure 8 of the software.
